#### OWNER'S STATUTORY DECLARATION

#### Relating to EQC Repairs – 6 Cedars Street, Hoon Hay, Christchurch

Master Claim: CLM/2011/136583 CLM/2010/099510 EQC/2018/000623 CLM/2012/035138 – Settled and paid out under master claim CLM/2011/136583

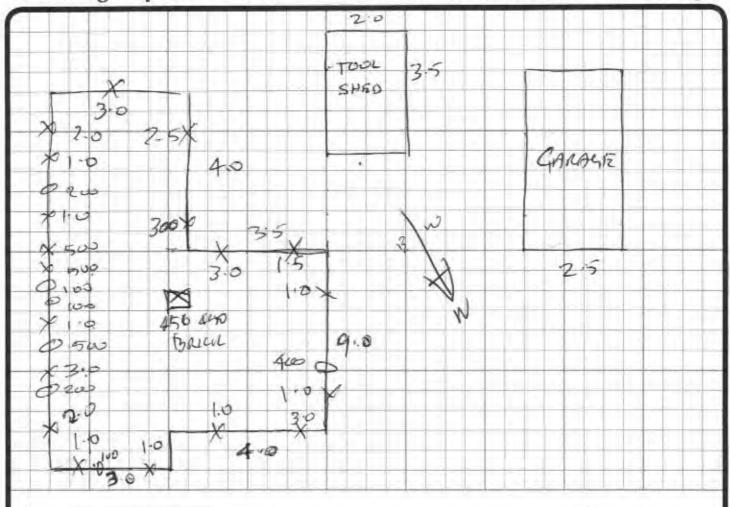
# Dwelling Inspection Checklist: Show measurements indicate damage

Area m2:	50m
Stud Heights:	2.4
Wall Finish:	Wallpaper Plastered Paint Finish
Other:	
Services:	Specify Damage:
Chimneys:	Construction Type: INTERNAL CHIMNEY  Height REMOVED PRESEARTHQUAKE.  Damage Description: Above Roof Below Roof Total Repair
Foundations Damage:	Timber Concrete Ring Concrete Slåb Other (Specify):  Minor Moderate Severe  House Moved off Foundations? NO  Concrete Slab Cracked? Crack Width:
Roof:	Trussed  Type: Clay Tiles Concrete Tiles Rolled Metal Other  Damage:
Cladding Type:	Weatherboard Brick Veneer Hardi Plank Other STUC
